LOCUST LAKE DAM

NJ 00126

**PHASE 1 INSPECTION REPORT
NATIONAL DAM SAFETY PROGRAM**

79 06 01 077
March, 1979

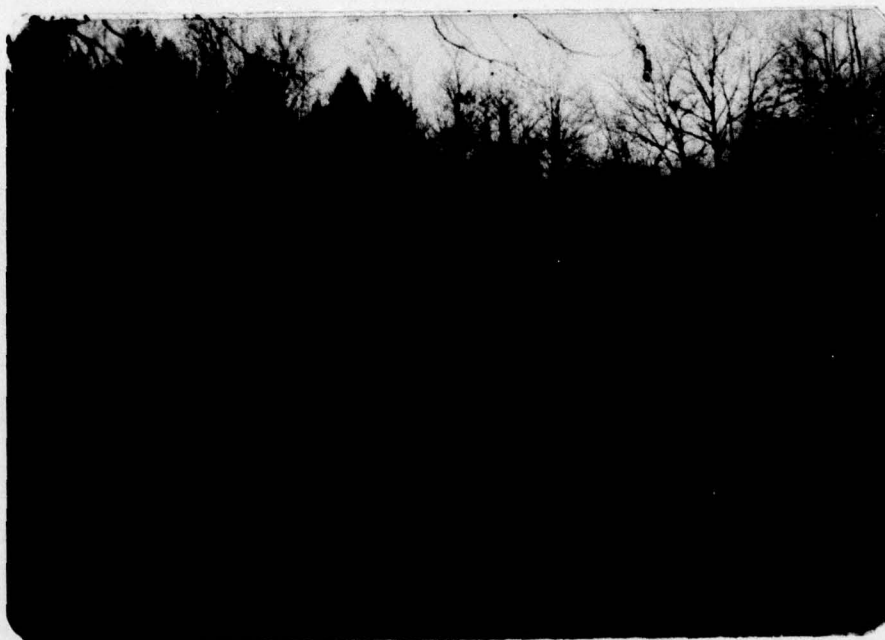
Upstream of dam and right abutment.
Looking South.

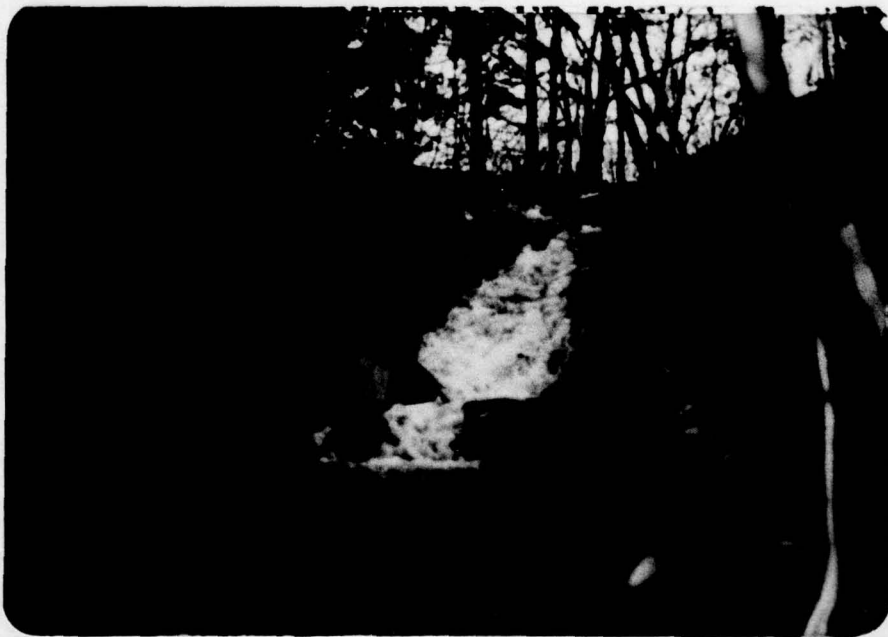
Discharge from spillway. Looking upstream. 6 December 1978

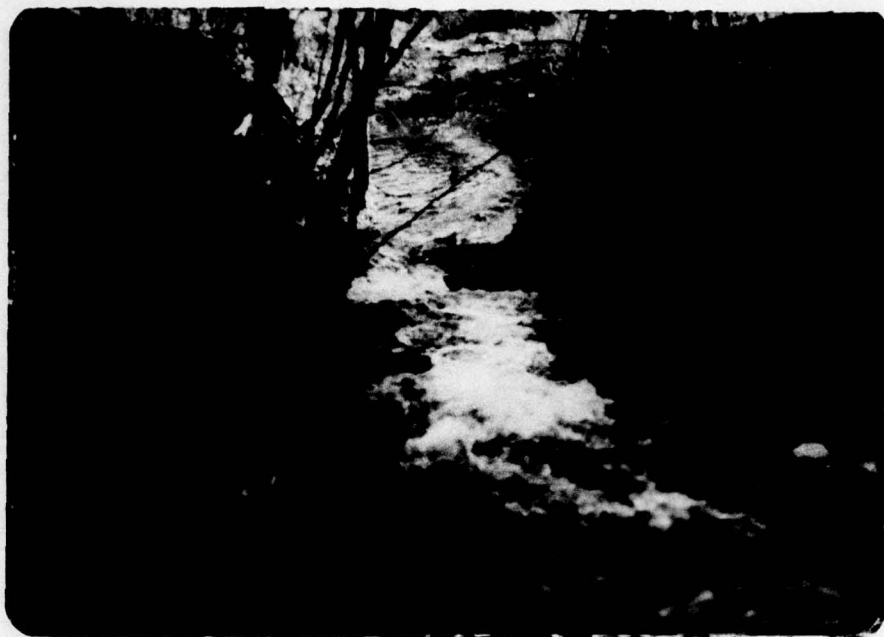
Spillway. Looking downstream.
